INSPECTION BULLETIN

Side Sill Closure Inspection and Repair

AMERICAN RAILCAR INDUSTRIES, INC.

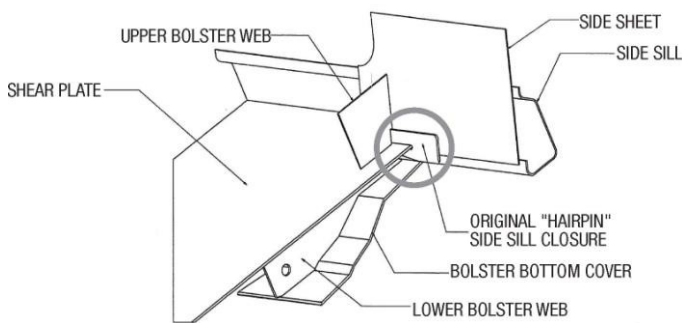
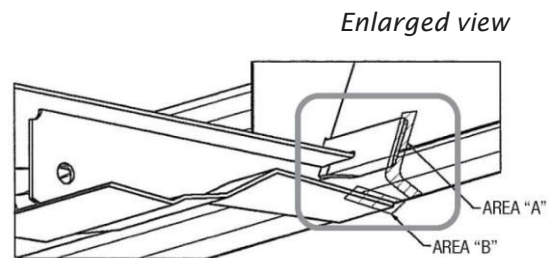
The side sill closure plate was utilized from 1978 – 2005. The areas shown below should be inspected for discontinuities in the form of cracks emanating from the welds at the inboard end of the closure plate attachment to the side sheet and at the bolster bottom cover attachment to the side sill. In all cases, replacement with a new closure plate is recommended at all four corners.

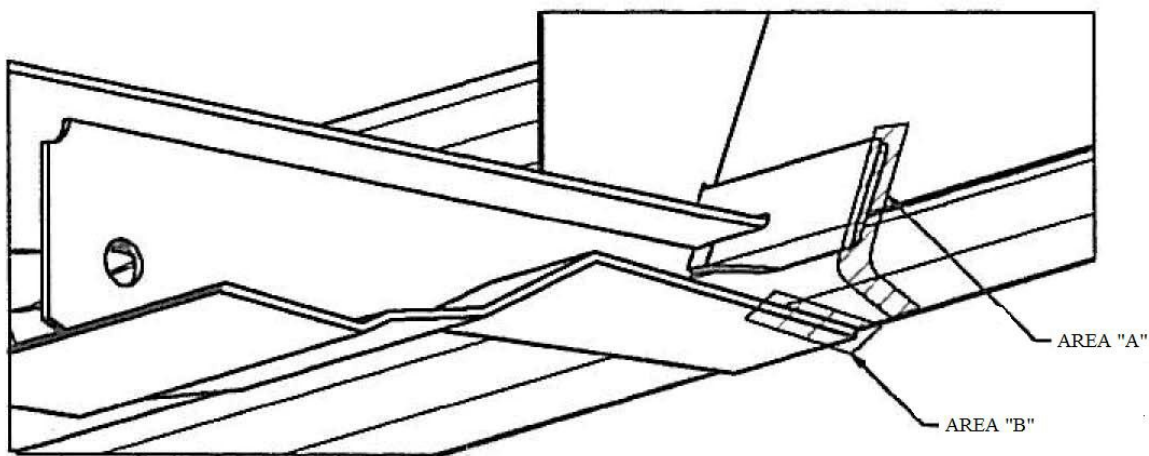
Inspection & Repair of Inboard Weld Termination

Cracks emanating from the welds can propagate up into the side sheet and down to the inside radius of the side sill and outward along the bottom of the side sill.

- Remove all dirt and debris from Areas “A” and “B” by wire brushing.
- Dye penetrate inspect these areas.
- If no cracking is found proceed with replacement of the side sill closure plate (recommended), or return the car to service. If the car is returned to service without replacement of the closure plate a plan should be implemented to inspect this area on a routine basis.

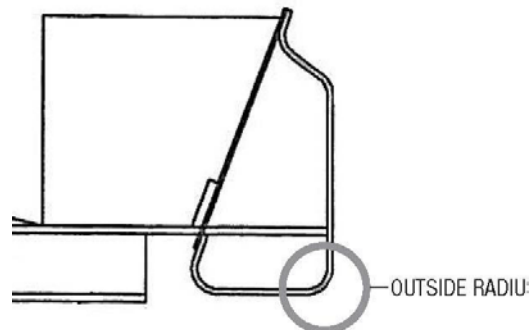
Critical Note: If any of the following special conditions are observed it will be necessary to replace a section of the side sill. See “Side Sill Section Replacement.”

- A crack that splits and branches in multiple directions
- Two or more cracks within 3” of one another
- A crack that propagates into the outside radius of the side sill, see below.

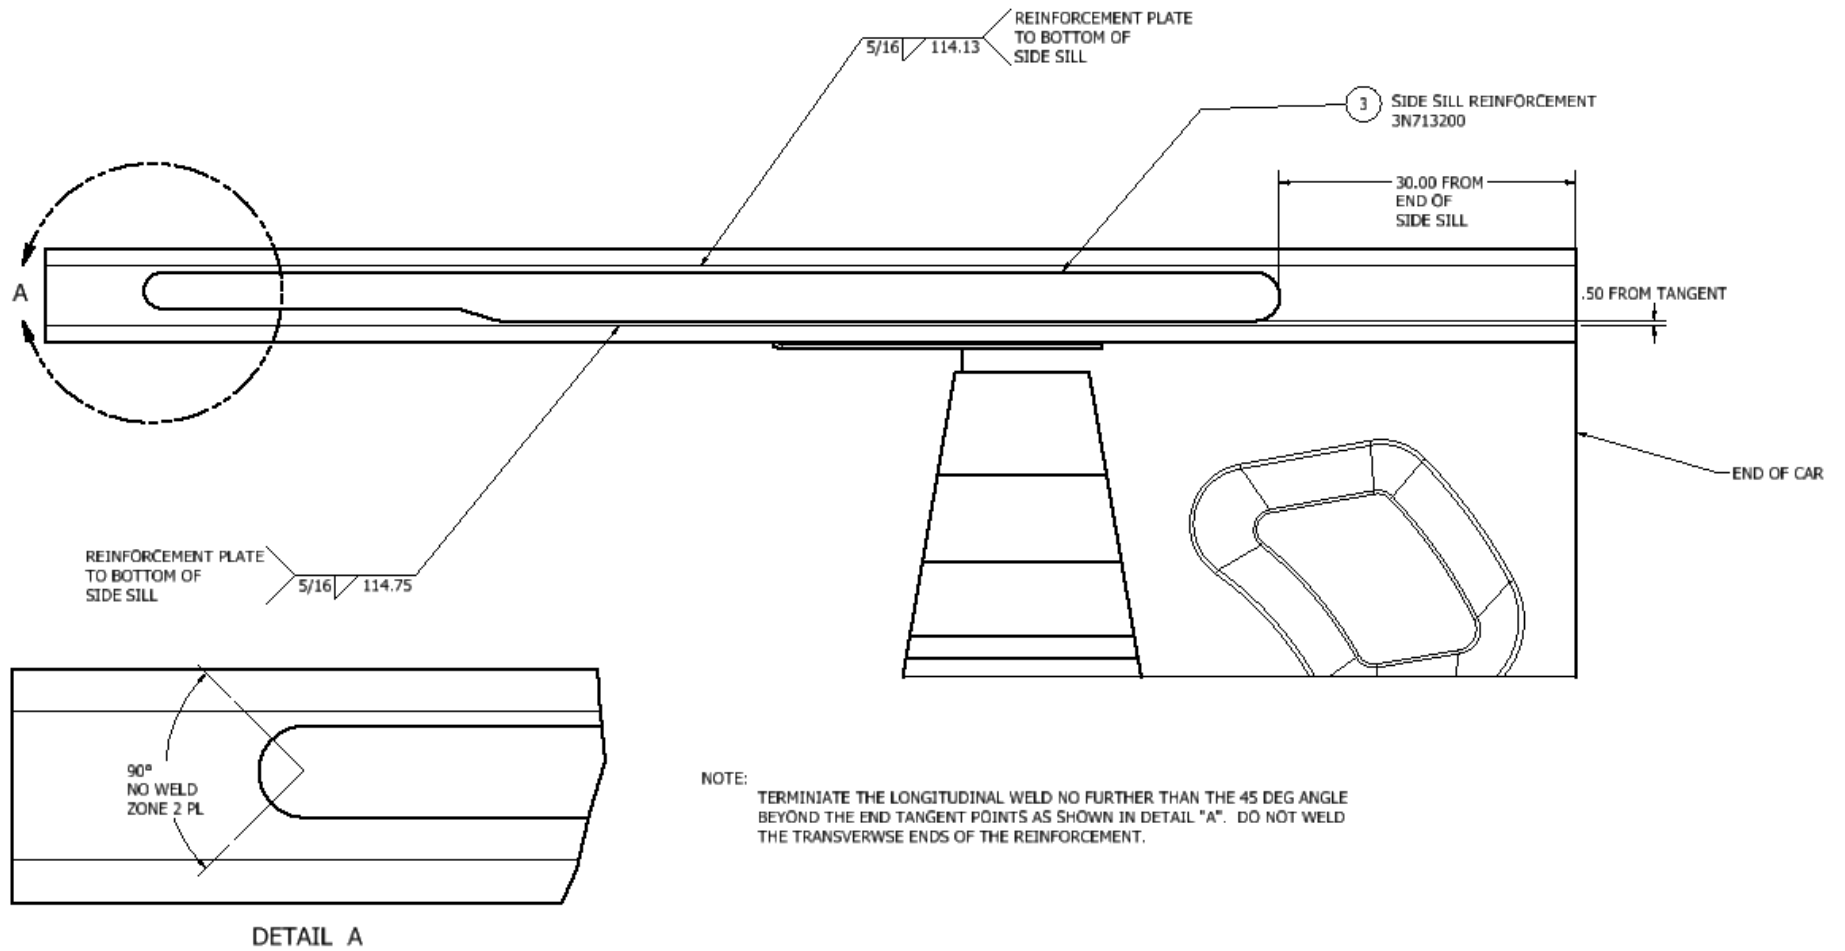
Side Sill Section Replacement

From the Critical Note on page 2, certain conditions necessitate replacing a section of the side sill. This area is defined as the "Critical Repair Area," and extends from the centerline of the adjacent compartment to a minimum of 8" beyond the centerline of the body bolster, or if desired, to the end of the car.

- A crack that splits and branches in multiple directions
- Two or more cracks within 3" of one another
- A crack that is open 1/32" or greater
- A crack that propagates into the outside radius of the side sill.

- Remove the Critical Repair Area sill section using air arc and exercising caution to avoid damage to the horizontal shear plate and side sheets.
- A tie plate connecting the bottom of the side sill to the compartment slope sheet is located at the centerline of each compartment. Split the tie plate in the middle and replace the side sill section by fitting a 1/8" x 2" backup strip and butt welding the two sections together using E7018 electrode or equivalent wire and ensuring 100% penetration.
- Relocate the roping staple 12" outboard of the body bolster web.
- Apply the previously removed section of tie plate and butt weld the two sections together.
