# ***INSPECTION & MAINTENANCE BULLETIN***

## ***ARI 1626 Vacuum Relief Valve***

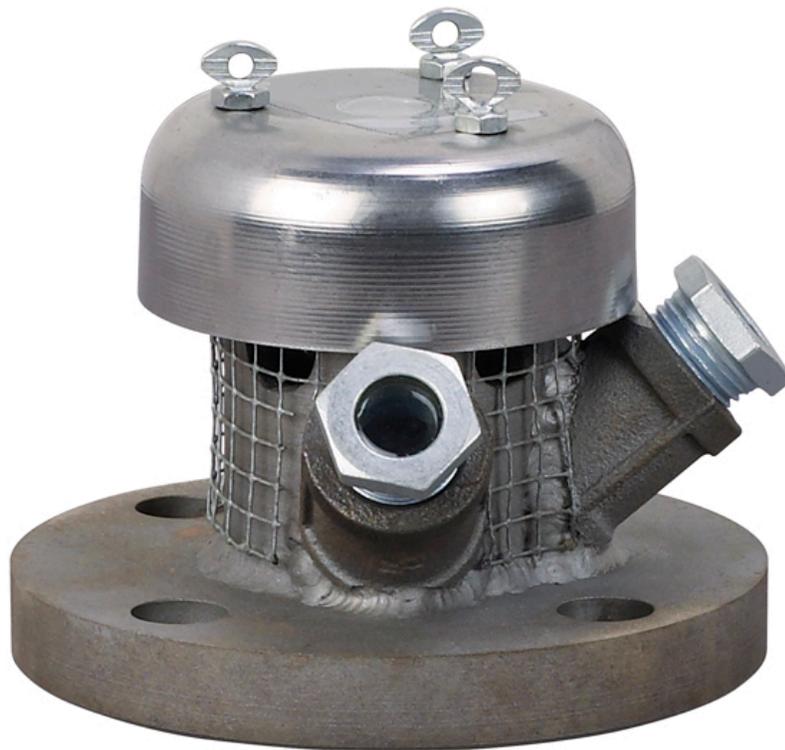
The ARI 1626 Vacuum Relief Valve is designed to be bubble tight from the specified negative set pressure to 165 psi positive pressure. This meets the requirements of AAR M-1002, Section C-III, Appendix A.

The most common reason for a leaking vacuum relief valve is a defective quad-ring on the stem.

If the valve is a model F flanged connection to the tank car instead of an NPT threaded connection, the quad-ring can be inspected without disassembling the valve. Do so by pulling the stem away from the bottom of the valve and inspecting the condition of the quad-ring. If it is deteriorated, cracked, or missing completely, then it should be replaced.

- 1) Cut and remove the cable seal going through the three thumbscrews on the top of the valve.
- 2) Unscrew the three thumbscrews on the top of the valve. Applying heat may be required because there may be thread locker on the threads.
- 3) Remove the hood from the valve.
- 4) Measure the distance from the top of the stem to the top of the stem nut. The same distance should be used for reassembly.

- 5) While securing the bottom of the stem with a vice or other device, unthread the nut on the top of the stem. This may also need heat applied due to thread locker on the threads.
- 6) Remove the seat and the spring from the stem and push the stem out of the body.
- 7) Inspect the condition of the quad-ring on the stem. If it is deteriorated, cracked, or missing completely, then it should be replaced.
- 8) Use an o-ring pick to remove the defective quad-ring from the groove in the stem. Be careful not to scratch the stem groove as it could make the stem unusable.
- 9) Apply the new quad-ring by firmly inserting it into the stem groove.
